NASA Contractor Report 172344

Flight Service Evaluation of Kevlar-49 Epoxy Composite Panels in Wide-bodied Commercial Transport Aircraft

Tenth and Final Annual Flight Service Report

LOCKHEED-CALIFORNIA COMPANY
BURBANK, CALIFORNIA

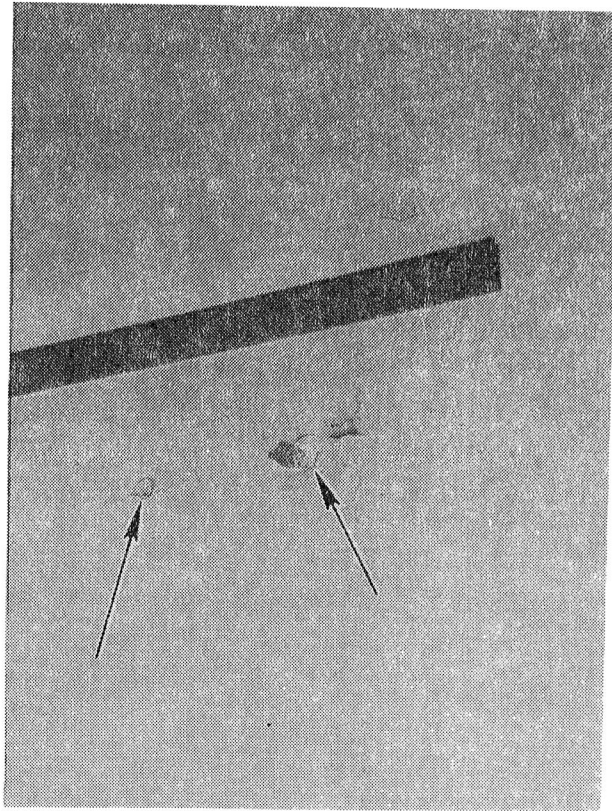
Figure A-1. - Eastern left-hand wing-body fairing - delamination areas connected by depression line.

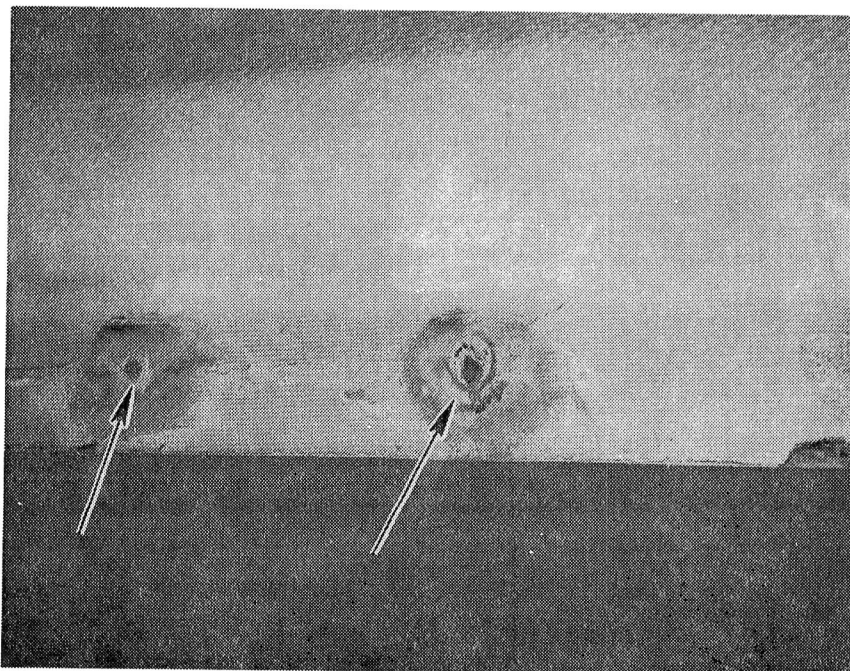
7. Most of the fastener holes were observed to have at least a slight degree of fraying. Several holes were noticeably more frayed (figure A-2) than the others, including two holes in the forward edge and eight holes on the lower edge. These fasteners holes had been redrilled upon reinstallation of these fairings in 1979, and several of these holes had a more pronounced fuzziness and frayed appearance than any holes previously observed in this program.

Figure A-2. - Eastern left-hand wing-body fairing - badly frayed holes.

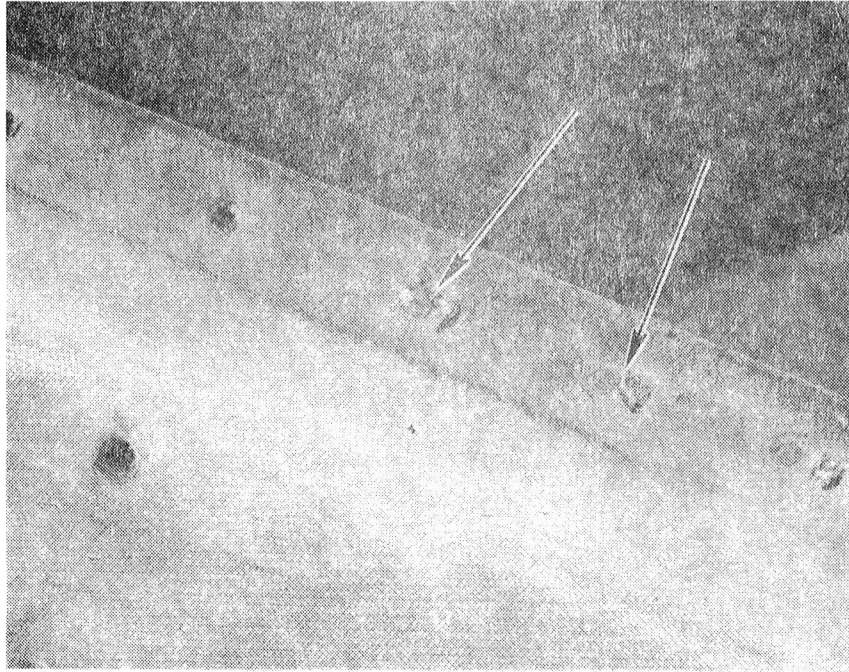
2. Despite the repainting, some areas of paint loss due to Skydrol were observed. These were primarily in the aft area of the part.
3. Most of the fastener holes in this part were redrilled through the Kevlar-49 and were fully offset from the filled area (figure A-3). These holes were all extremely frayed (figure A-4), and the fuzziness and frayed condition was noticeably worse than the holes previously observed on this program. Elongation was noted in about 12 holes (out of a total of approximately 110 holes), and this elongation occurred mainly in areas where the hole was redrilled through a portion of the filled original hole. The elongations ranged from 0.55 cm (7/32 in.) to 0.7 cm (9/32 in.) compared to the original 0.5 cm (3/16 in.) diameter. The degree of fraying had not increased since the redrilled holes were first observed in the 1981 inspection.

Figure A-3. - Eastern left-hand aft engine fairing - redrilled fastener holes partially and fully offset from filled holes.

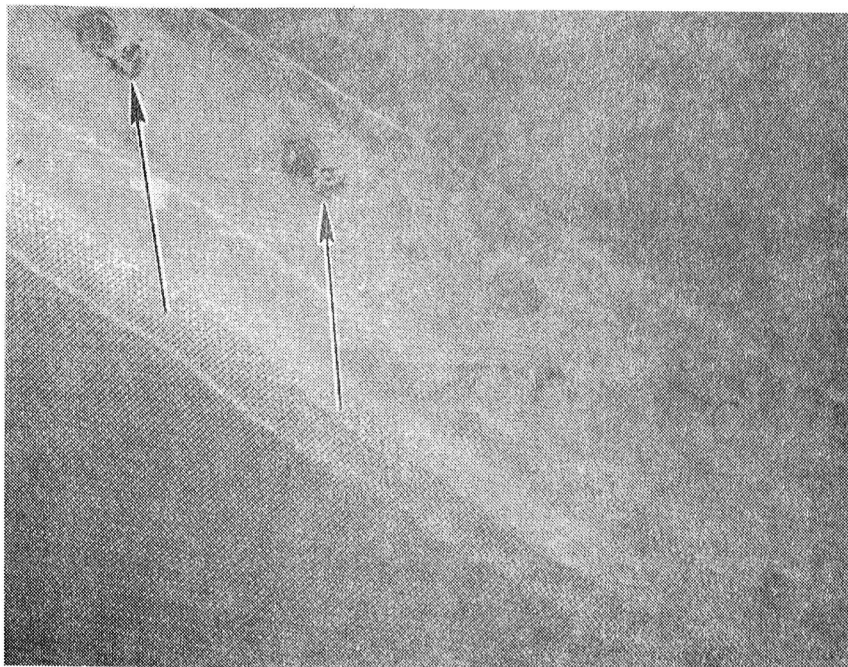
Figure A-4. - Eastern left-hand aft engine fairing showing extreme frayed condition of redrilled holes.

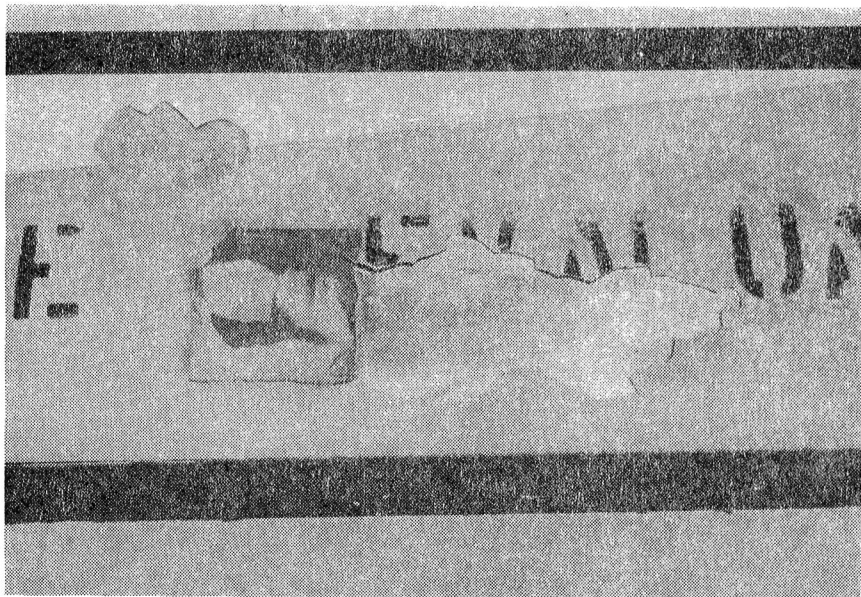
1. A tape patch repair of a deep gouge, first observed in 1980, on the exterior surface was still in place with no changes in appearance since the previous inspection (figure B-1). There was some paint loss near the patch, but no delamination or evidence of damage growth.

Figure B-1. - TWA left-hand wing-body fairing - tape patch repair of deep gouge.

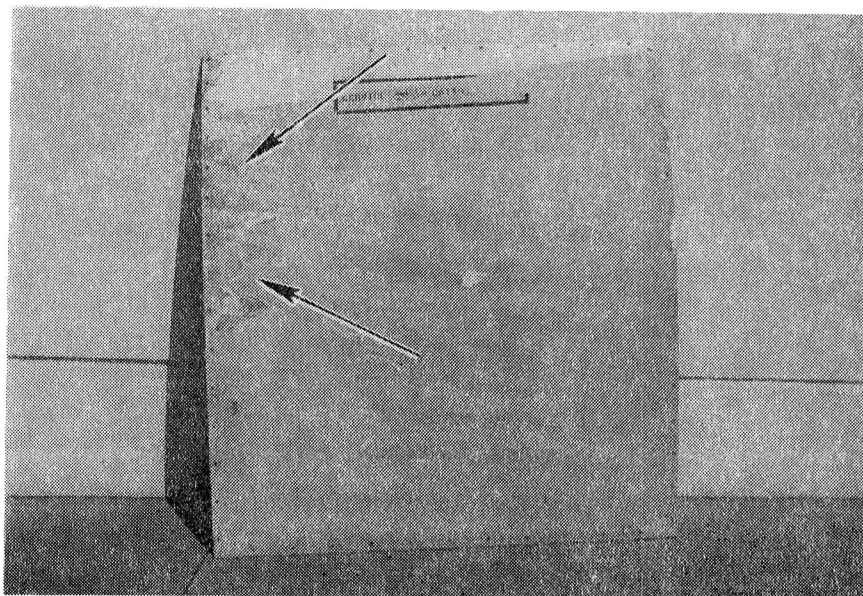
3. An area of extensive paint loss along the forward edge was still present indicating probable Skydrol exposure (figure B-2). This area had not increased significantly since it was first noted in the 1982 inspection. Flame spray was intact in this area preventing any exposure of the Kevlar to ultraviolet.

Figure B-2. - TWA left-hand wing-body fairing - exterior surface showing paint loss area.

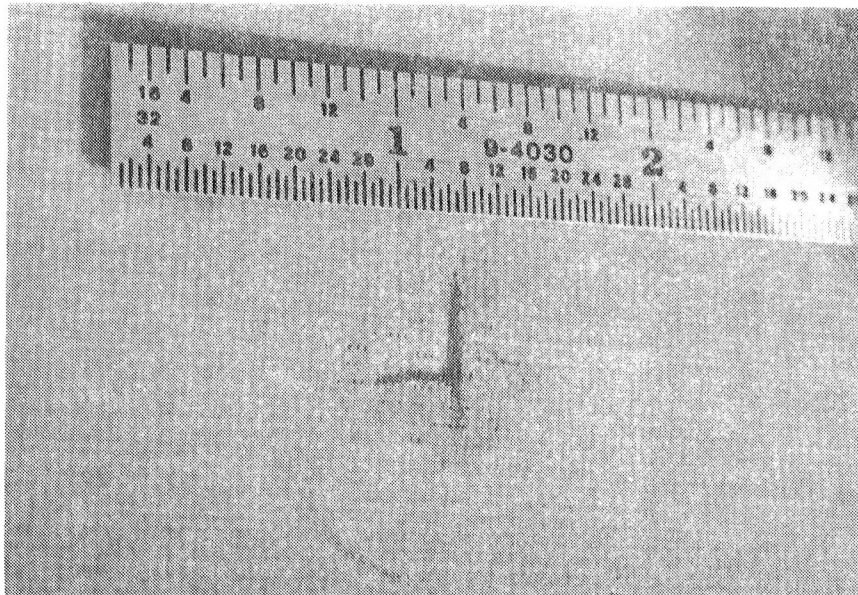
4. A crack 1.3 cm (1/2 in.) in total length was noted in the upper aft area of the inner skin (figure B-3). The crack completely penetrated the skin, and had associated delamination extending 0.3 cm (1/8 in.) on both sides of the crack. This damage had not been observed previously.

Figure B-3. - TWA left-hand wing-body fairing - crack and skin penetration on inner surface.

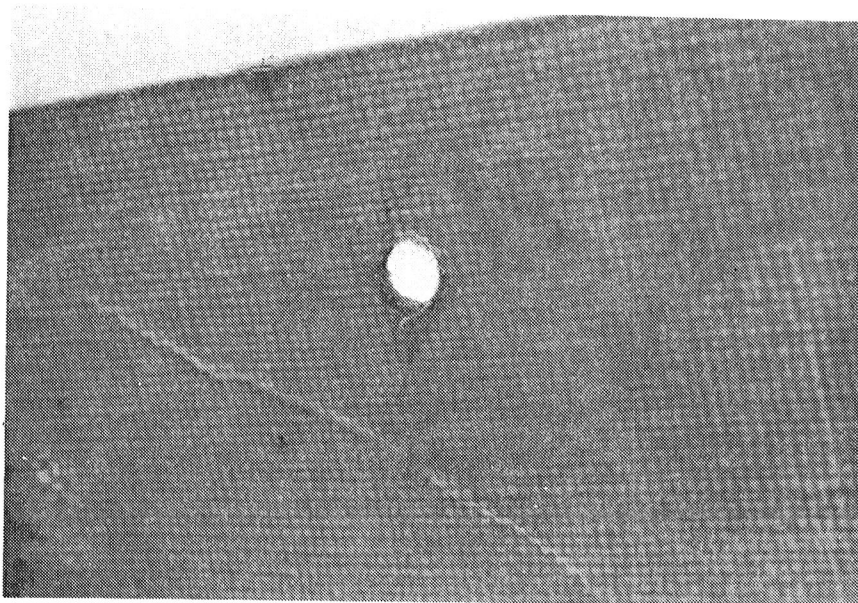
Figure B-4. - TWA left-hand wing-body fairing - typical fastener hole with slight fraying.

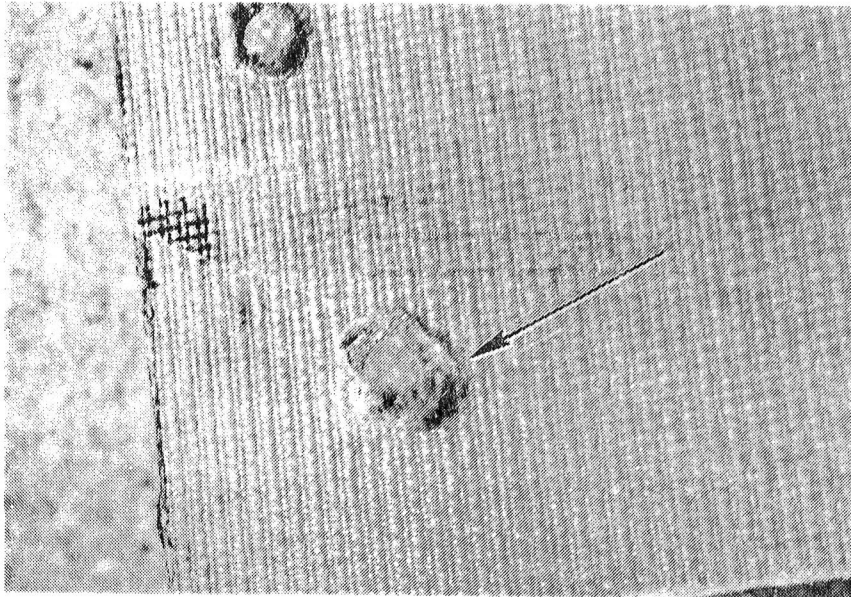
Figure B-5. - TWA right-hand underwing fillet - badly frayed holes.

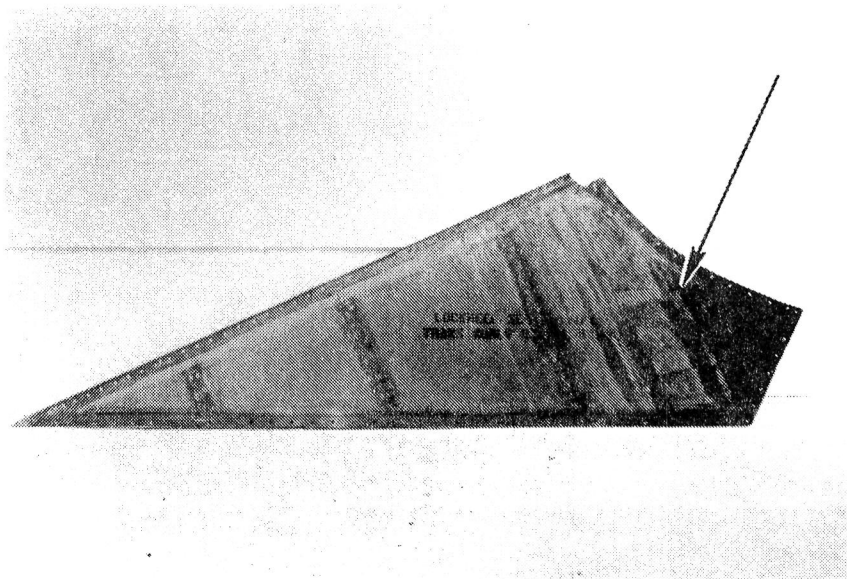
Figure B-6. - TWA right-hand aft engine fairing - inner surface showing Skydrol attack on coating.

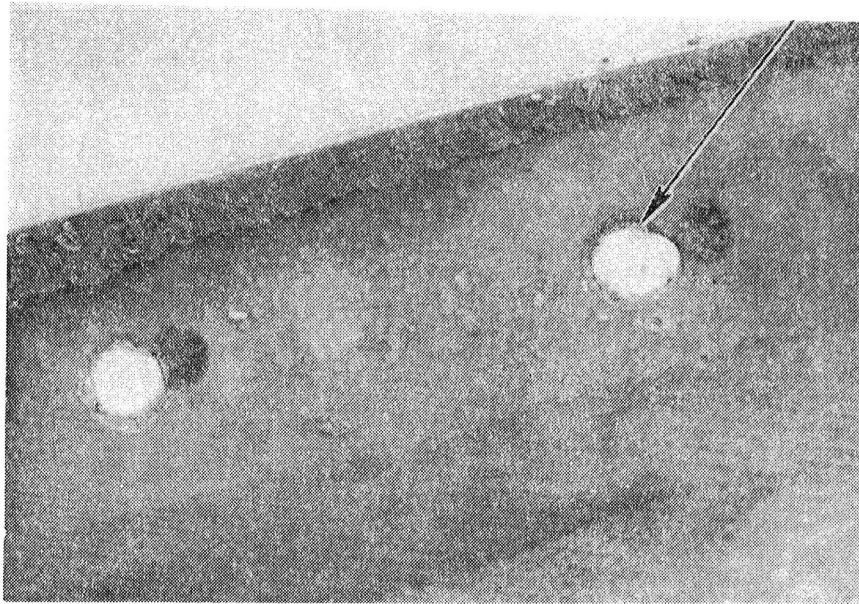
Figure B-7. - TWA right-hand aft engine fairing - fastener holes showing elongation and absence of fraying.

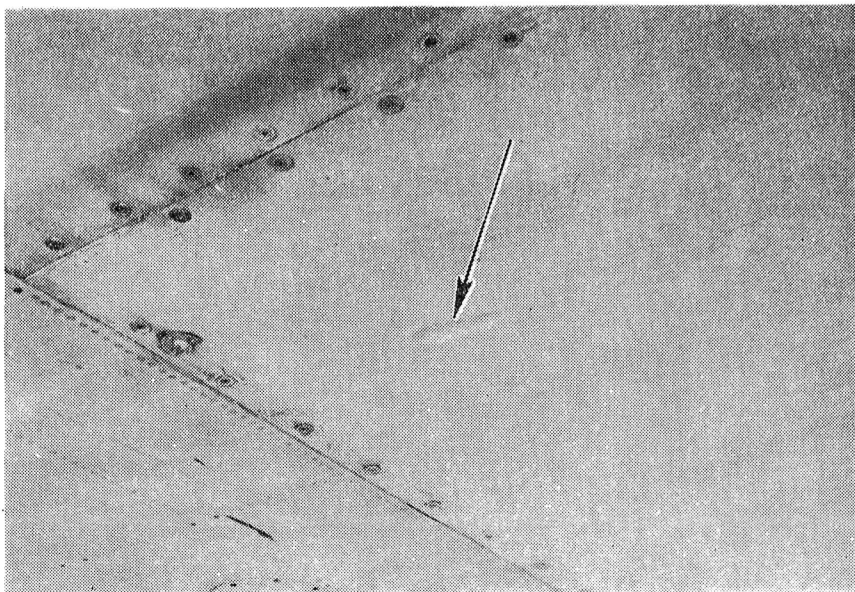
Figure B-8. - TWA right-hand wing-body fairing on the aircraft showing large disbond area.

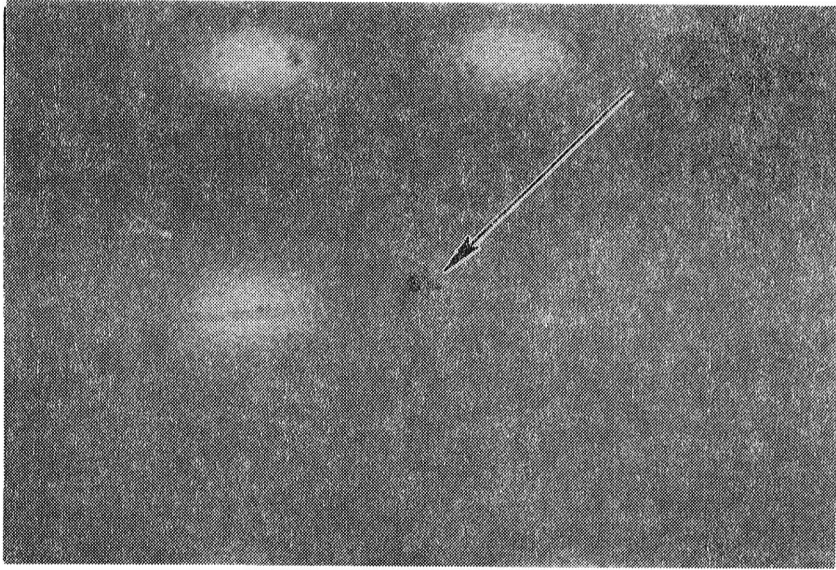
Figure C-1. - Air Canada left-hand wing-body fairing - deep gouge on exterior surface.

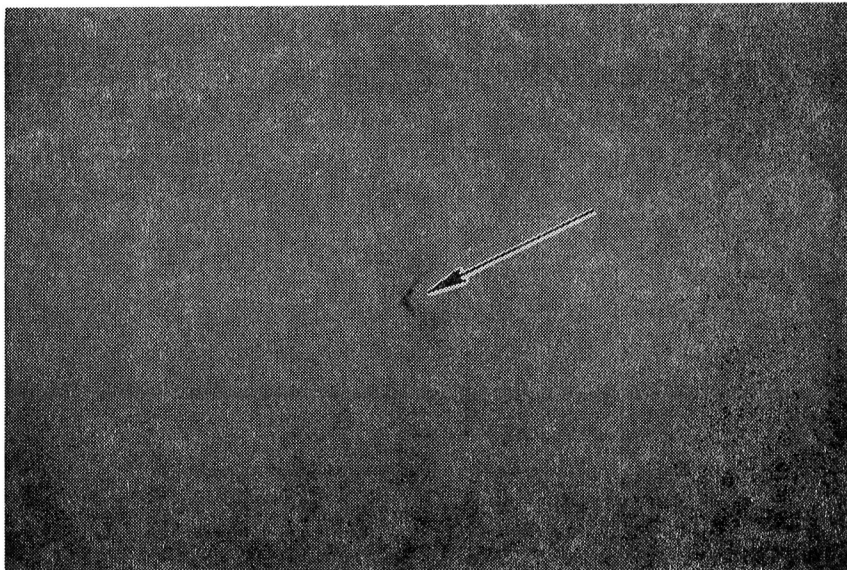
Figure C-2. - Air Canada left-hand wing-body fairing - crack on inner surface 1.3 cm (1/2 inch) length.

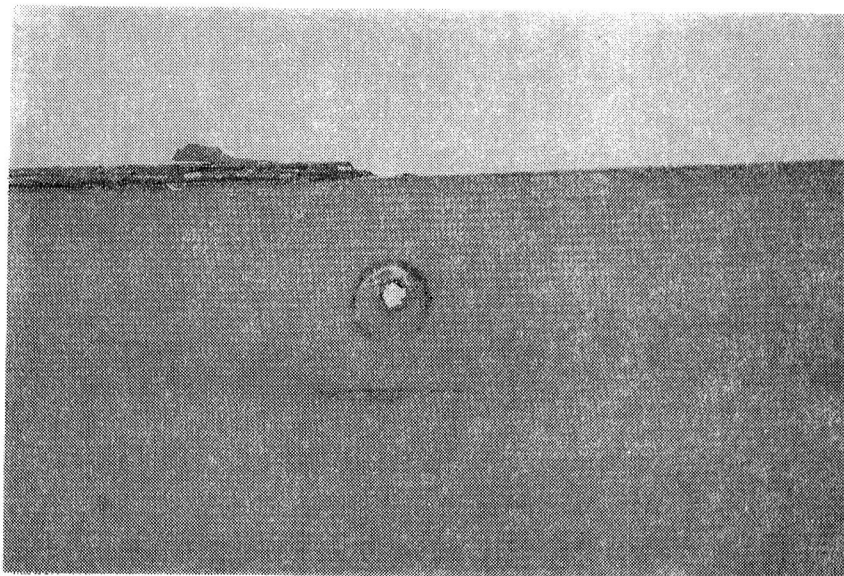
Figure C-3. - Air Canada left-hand wing-body fairing - fastener hole on lower edge with mark-off, slight fraying.

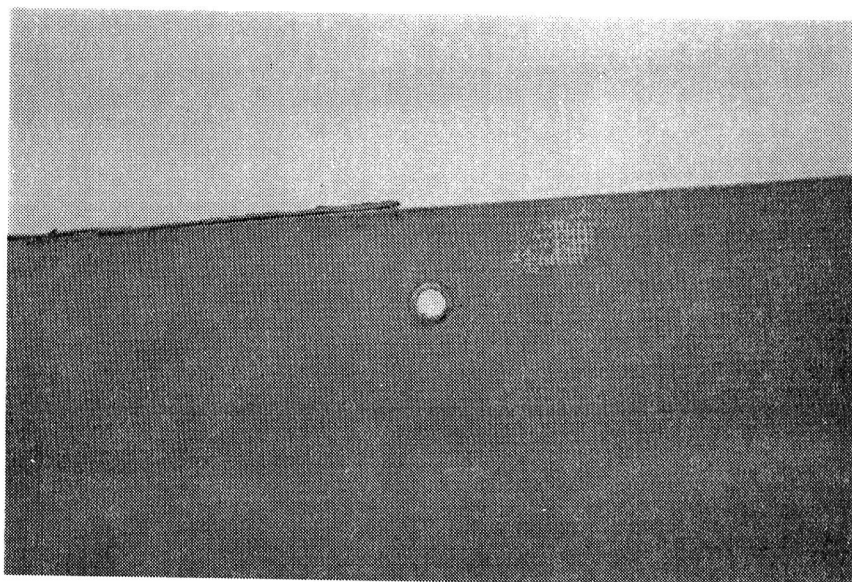
Figure C-4. - Air Canada left-hand wing-body fairing - typical hole with very slight fraying and no elongation.

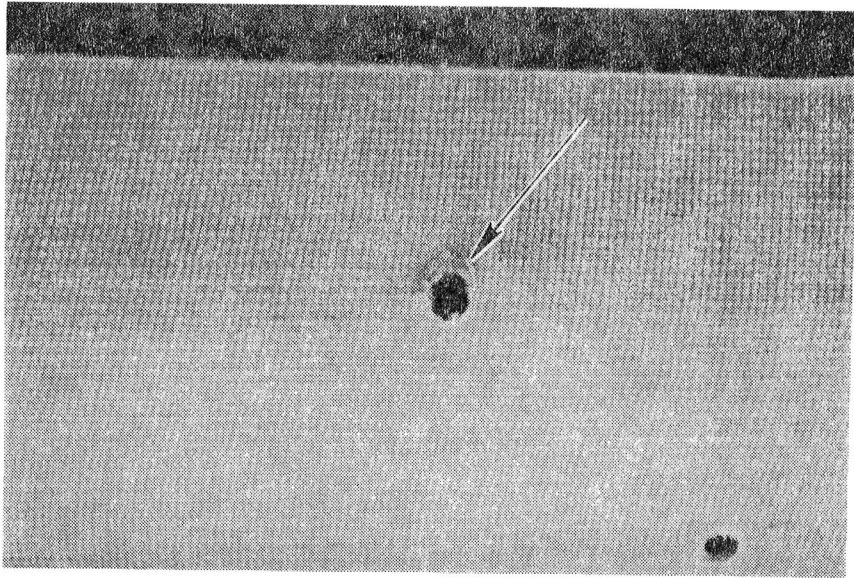
Figure C-5. - Air Canada left-hand underwing fillet - badly elongated and frayed hole.

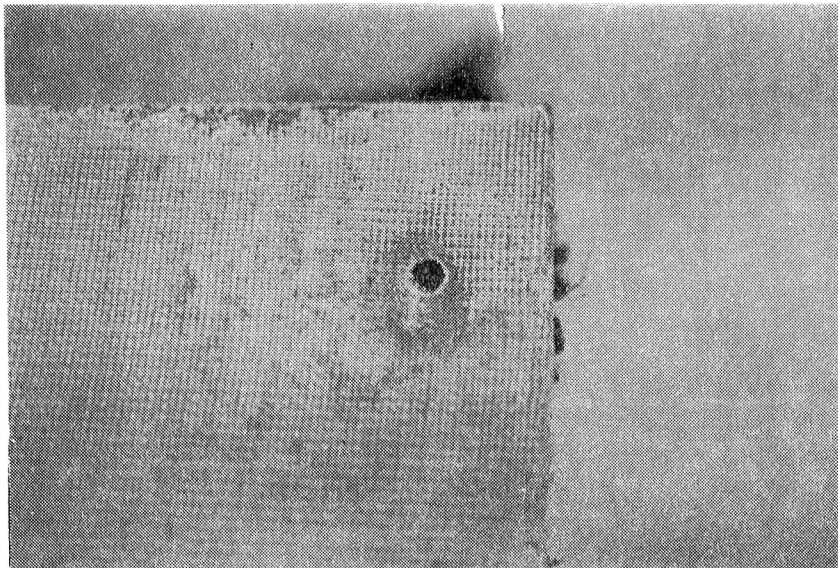
Figure C-6. - Air Canada left-hand underwing fillet - typical hole with very slight fraying, no elongation.

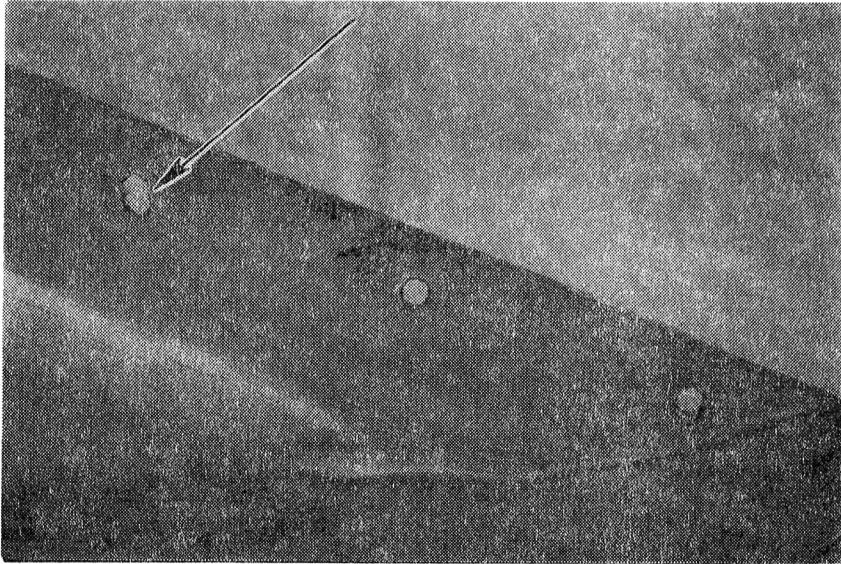
Figure C-7. - Air Canada right-hand aft engine fairing - typical holes with very slight fraying; badly elongated hole.
